**CONESTOGA-ROVERS
& ASSOCIATES**

Reference No. 073982

Re: Environmental Site Assessment
Kuntz Topsoil

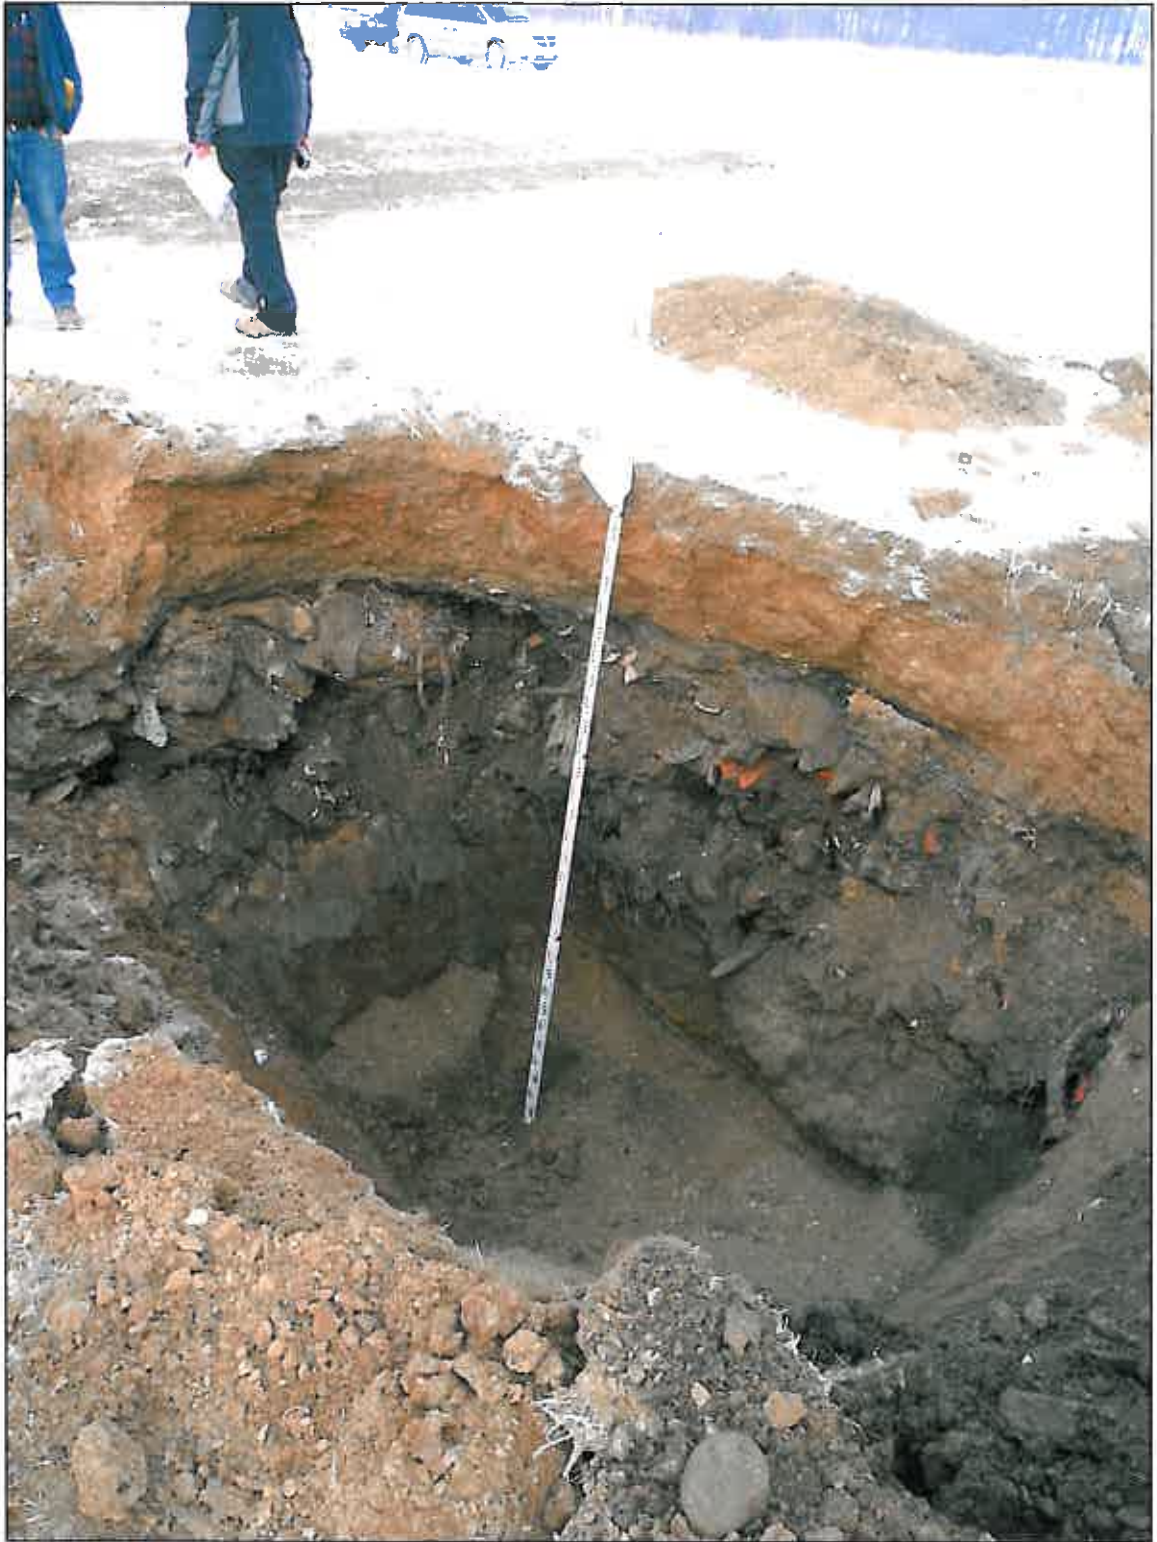
TEST PIT #3
KUNTZ TOPSOIL
125 Peel Street, Woolwich, Ontario

- There were no odours noted with the exception of a slight oily aroma from the fill material from Test Pit 3 (only noticeable when very close to the material).

- As part of the assessment, a photoionization detector unit was used to scan the air quality for organic vapors immediately adjacent to the excavated materials (within 1 cm.) of Test Pits 3 and 4. All readings were non-detect signifying that there were no organic vapors emitting from the fill materials.

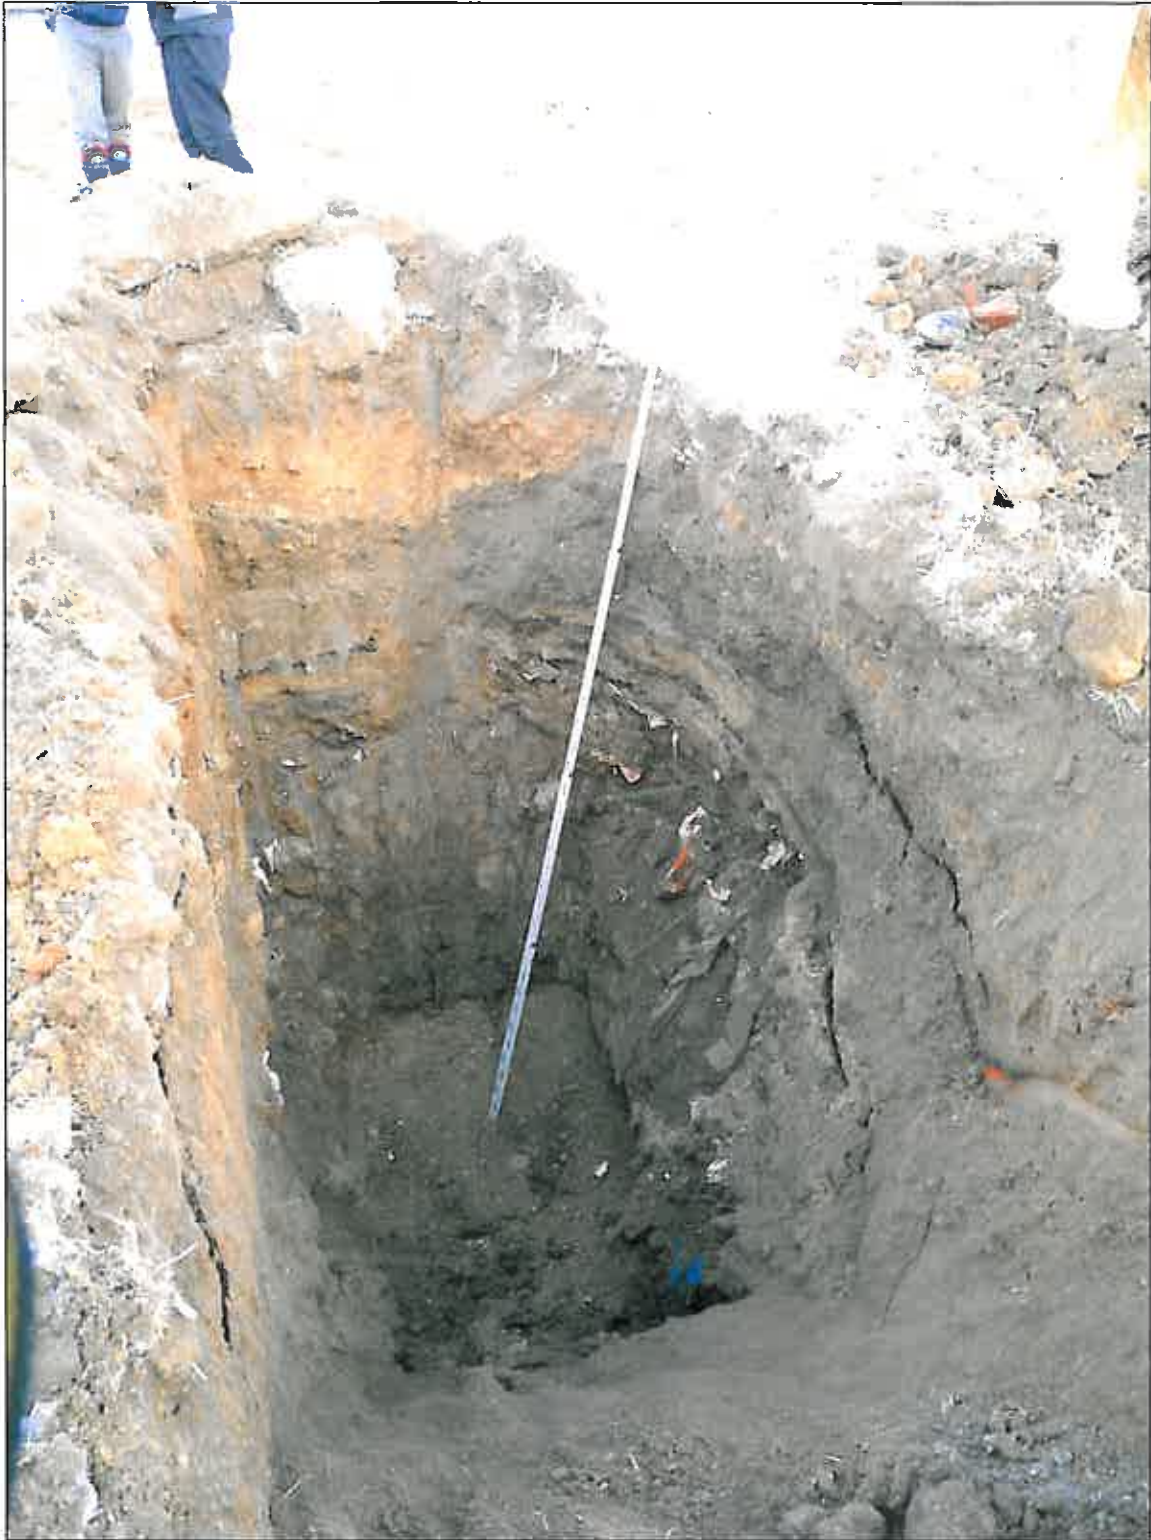
TEST PIT #4
KUNTZ TOPSOIL
125 Peel Street, Woolwich, Ontario

- The maximum depth of fill material encountered in the test pits was 3.2 meters below the existing ground surface at Test Pit 4.
- The fill materials encountered primarily consisted of inert materials such as brick, concrete, and stone rubble set in a soil matrix. Some pieces of metal, plastic, gypsum, and the occasional piece of glass were also encountered. Consistent with the information provided by Mr. Weber, there was little wood. No putrescible material was encountered.
