**Montrose Pit**  
**Category 1 – Class “A” Licence, Pit Below Water**  
**For Capital Paving Inc.**

**Visual Impact Assessment Report**  
**July 2008**

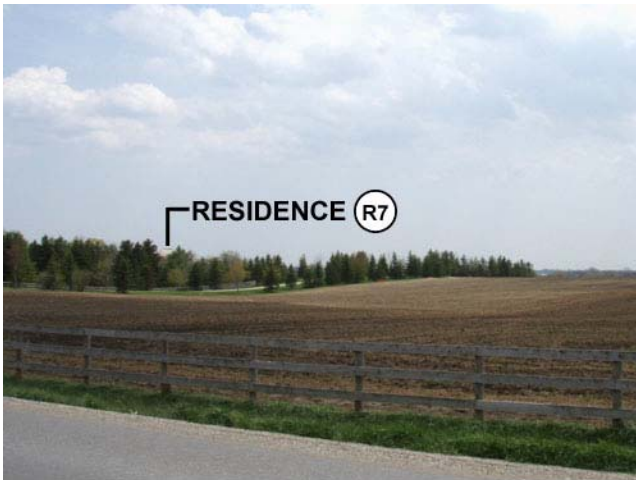
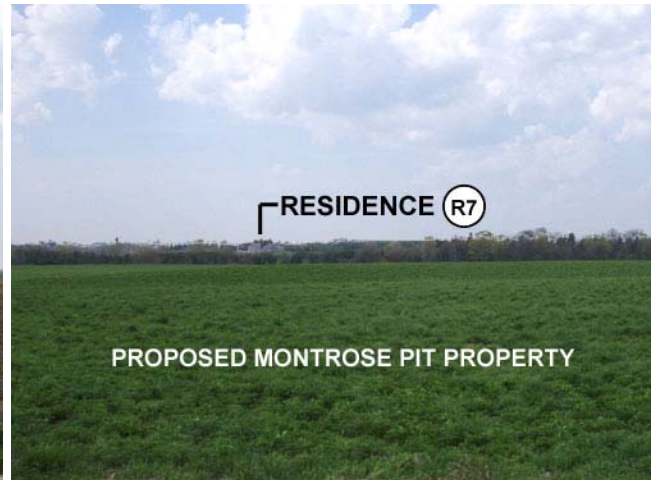
The entrance to Residence R7 is located on Hill Street just east of Township Road 46. Residence R7 is approximately 720m northwest of the Proposed Montrose Pit Property. This home is located at a much higher elevation than the Proposed Montrose Pit Property and overlooks the Grand River. This home is barely visible from Hill Street due to the surrounding woodlot and coniferous screening, as one can see in Figure 4a. However, looking northwest from within the Proposed Montrose Pit Property one can see Residence R7 in the Far Background. Refer to Figure 4b. Therefore, it is assumed that the Proposed Montrose Pit Property will sit in the far background of the View Southeast from R7.

FIGURE 4a. View 1  
*View from the Southeast towards R7*

FIGURE 4b. View 1  
*View from the Southeast towards R7*

This view will be slightly modified throughout all the phases of operations proposed for this pit. The Proposed Montrose Pit Property sits in the far background of this view, which means any visual impact caused by the proposed pit operations will be negligible.

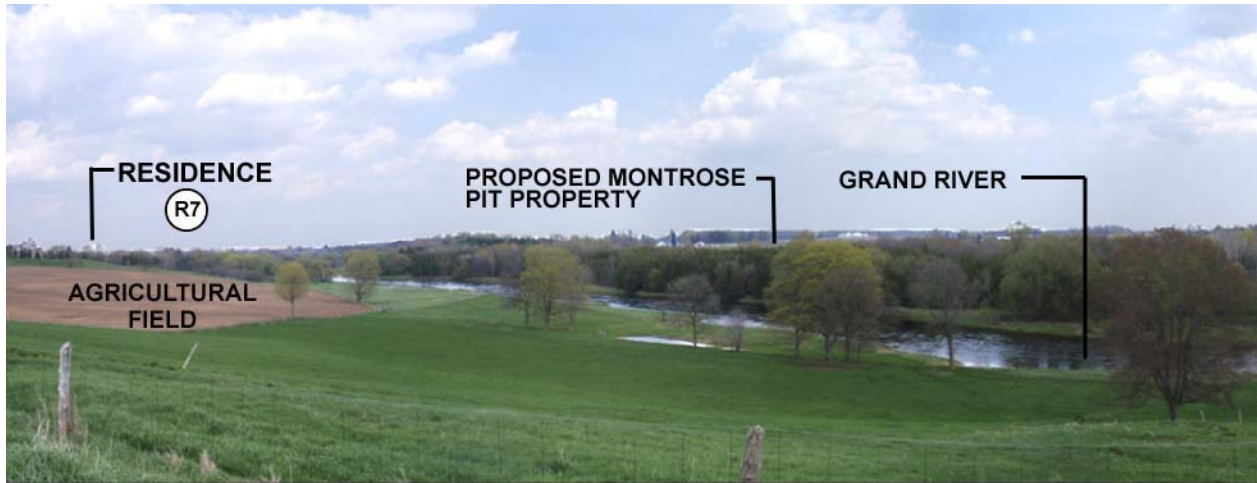
There is a section of Township Road 46 that is at a higher elevation than the Proposed Montrose Pit Property. This section is just north of Residence R8 approximately 420m northwest of the Proposed Montrose Pit Property. From this location and from Residence R8 there is an expansive view of an agricultural field, the Grand River, and the woodlot in the background. There is no visual barrier restricting the view to Township Road 46. As a result, the Proposed Montrose Pit Property is visible in the far background along the skyline.

FIGURE 5. View 2  
View East at R8 and R9

This view will be slightly modified throughout all the phases of operations proposed for this pit. The Proposed Montrose Pit Property sits in the far background of this view, which means any visual impact caused by the proposed pit operations will be negligible.

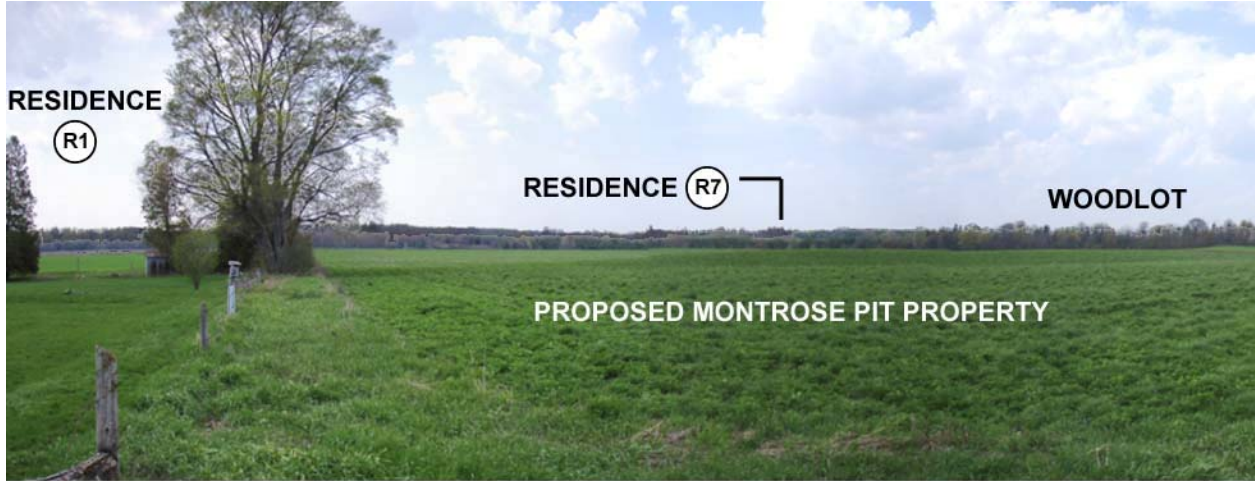
FIGURE 8a. View 5  
*View North at R1*

Residence R1 is located on Letson Drive adjacent to the south licence boundary of the Proposed Montrose Pit Property. There is currently a sparse vegetated visual barrier between the two properties, however, the view of the Proposed Montrose Pit Property is dominant at this residence. Figure 9 is the view west of Letson Drive, while Figure 10 is the view east of Letson Drive.

FIGURE 8b. View 5  
*View North at R1*

The view of the Proposed Montrose Pit Property west of Letson Drive will be drastically modified throughout all the phases of operations proposed for this pit. The view of the Proposed Montrose Pit Property east of Letson Drive will begin to be drastically modified during Phase F of the operations plan. There is a lack of an existing visual barrier, so all proposed pit operations will be left exposed to Residence R1 and to users of Letson Drive and the Grand Valley Trail.

It is recommended that before the operations of **Phase A** commence a minimum 3m high vegetated berm be installed along the south licence boundary west of Letson Drive and along the west side of Letson Drive between the road and Area 5 as temporary visual barriers. It is also recommended that a similar vegetated berm be installed along the south licence boundary east of Letson Drive before the operations of **Phase F** commence. The existing trees along this licence boundary will soften the dominant impact of the berm within the landscape. Upon rehabilitation of the site the berms will have been removed and the property will be compatible with its surrounding landscape.

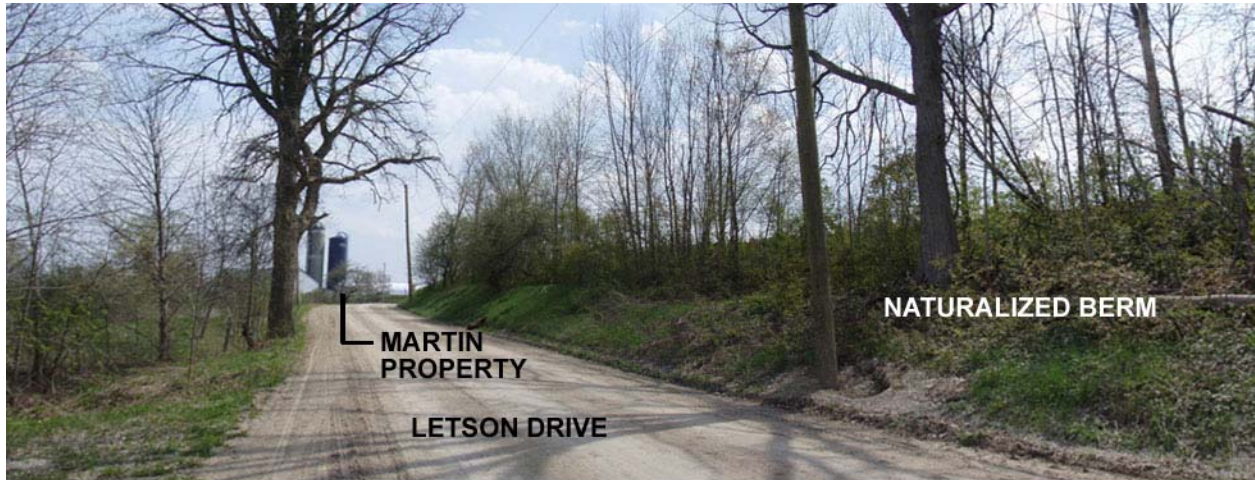
Residence R3 is located north of the Proposed Montrose Pit Property across Letson Drive from Residence R4. One of the residence's entrances is on Letson Drive. From this point one would see Letson Drive, a naturalized berm, and the silos on the Martin Property in the background.

FIGURE 10. View 7  
*View South at R3*

This view will not be modified by the operations of the Proposed Montrose Pit.

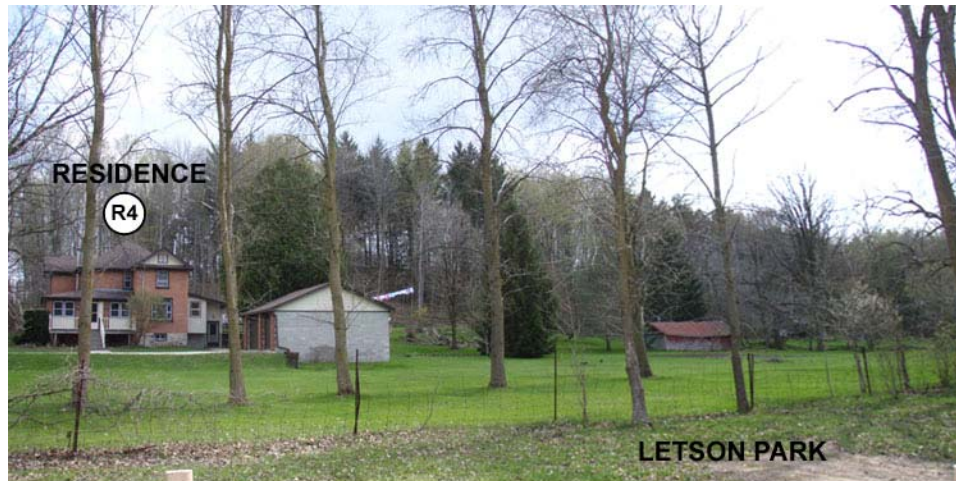
Residence R4 is located north of the Proposed Montrose Pit Property on Letson Drive. Just north of this residence is Letson Park. This residence and park sit at a lower elevation than the Proposed Montrose Pit Property and a visual barrier of mature vegetation sits on the hillside at the southern border of Residence R4.

FIGURE 11. View 8  
*View South at R4*

This view will not be modified by the operations of the Proposed Montrose Pit.

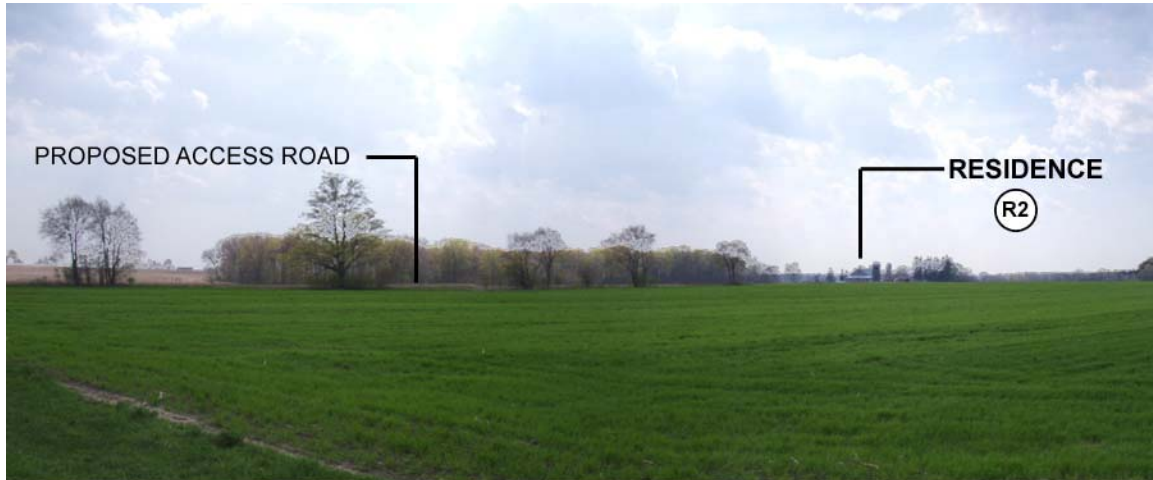
West Montrose School is a small building located just north of Residence R13. From the school's entranceway on Katherine Street North (Regional Road 23) one would view the Access Road for the Proposed Montrose Pit Property.

FIGURE 12. View 9  
*View West at West Montrose School*

This view will not be modified by the operations of the Proposed Montrose Pit. The proposed Access Road for the Montrose Pit Property will be compatible with the access road located directly across Katherine Street North (Regional Road 23) and its surrounding rural landscape.

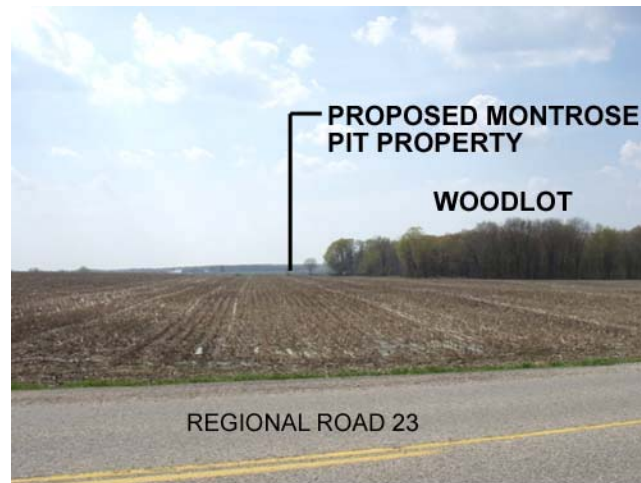
Residence R12 is located on Katherine Street North (Regional Road 23) at a slightly higher elevation approximately 775m east of the Proposed Montrose Pit Property. There is an existing woodlot northwest of Residence R12 but its location only screens the view of the northern parts of the Proposed Montrose Pit Property. From Residence R12, one would view the Proposed Montrose Pit Property in the far background.

FIGURE 14. View 11  
View West at R12

This view will be slightly modified throughout all the phases of operations proposed for this pit. The Proposed Montrose Pit Property sits in the far background of this view, which means any visual impact caused by the proposed pit operations will be negligible.
