CONESTOGO MILL PROJECT

PRESERVATION & REJUVENATION

KENTON SHANTZ

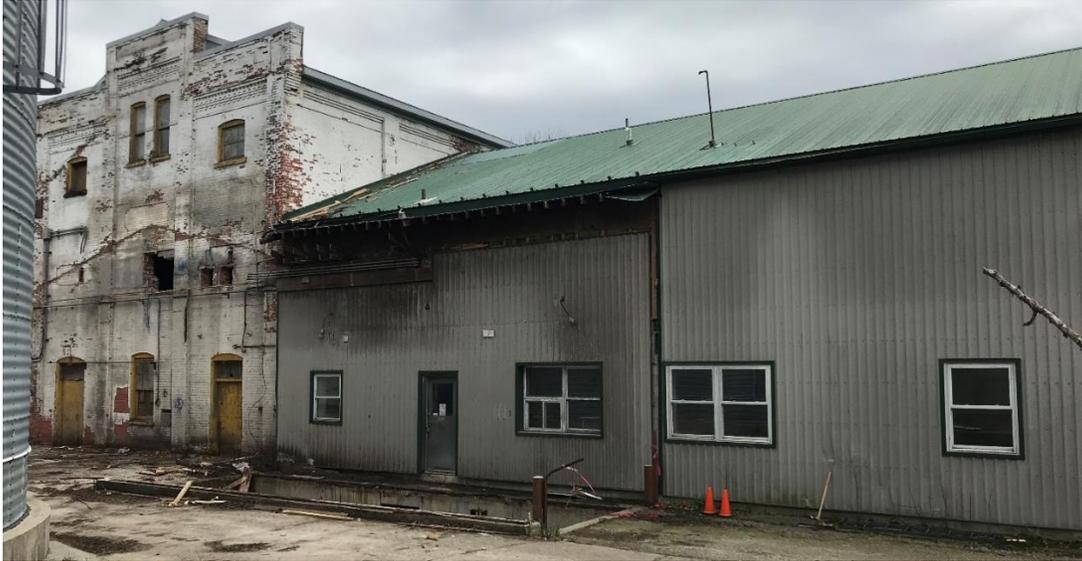
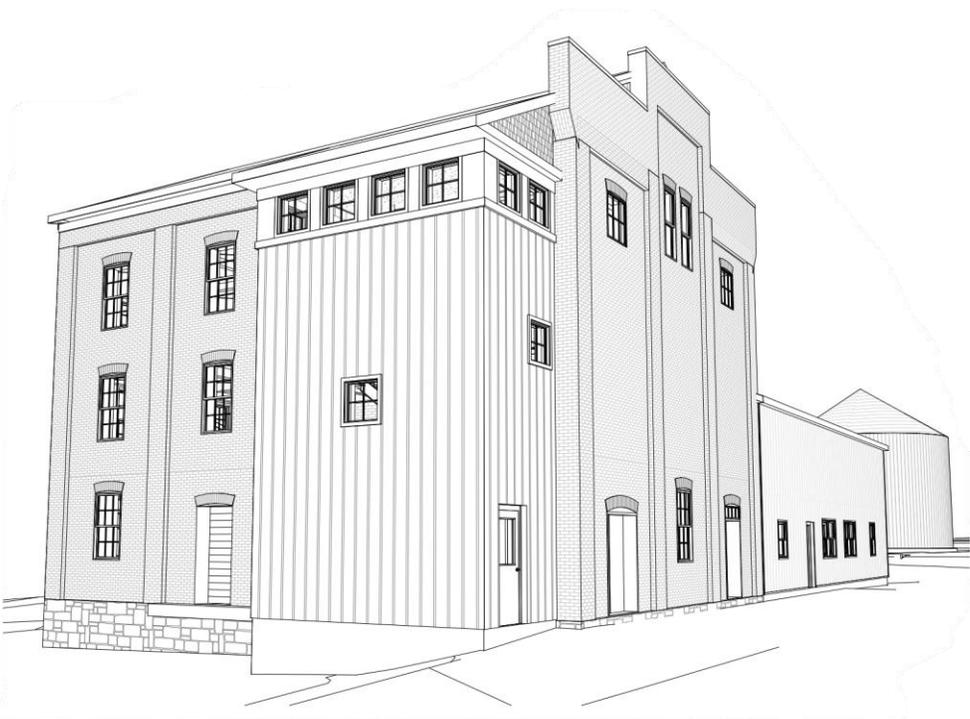
An example of a change required to meet the standards of the Ontario Building Code is the stair tower visible on the front page. This is required to provide occupants with a safe way of exiting from all floor areas. Our design proposal is careful to avoid trying to match the existing century old materials of the mill but rather uses a style that will complement the original building's

powerful geometry and materials for years to come. It is also designed in such a way to minimize any impact on the existing mill's imposing façade. The stair tower is necessary and is designed to be a feature that enhances rather than detracting from the silhouette of the existing structure.

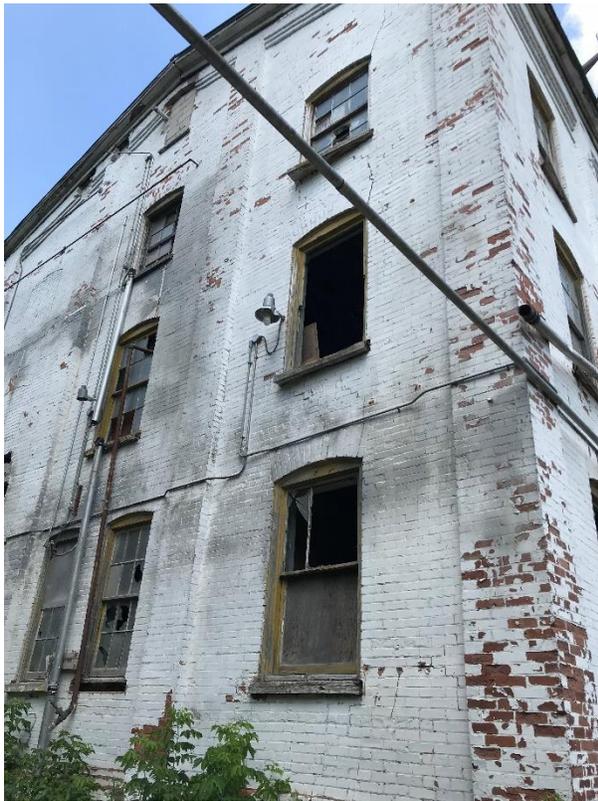
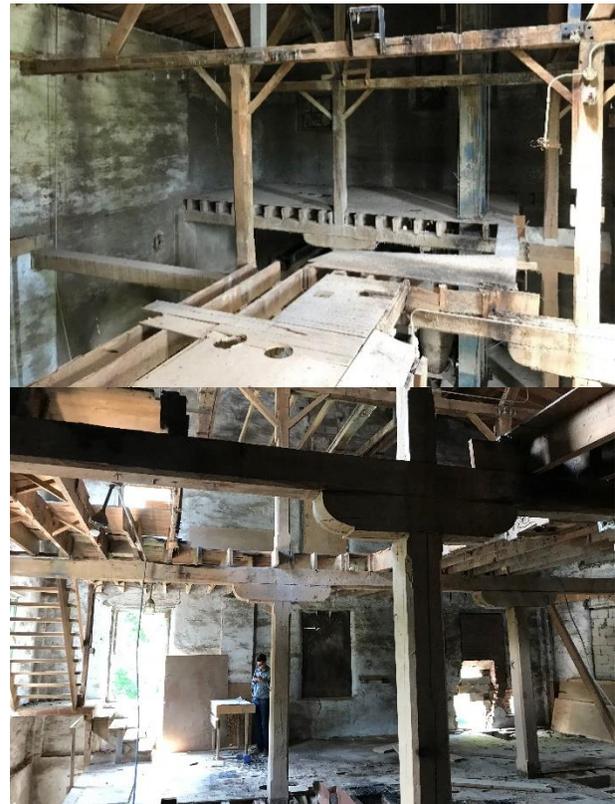
The brick is the main item requiring refurbishment on the exterior of the structure. Multiple courses of action to this end were mentioned in the report. These include: determining locations with irreparable brick and replacing them, removing the paint, installing flashings over the more vulnerable bricks located in the wash courses, and filling in window and door openings that are to be unused in the new design. Repairing the brick is necessary from structural and aesthetic viewpoints. Another item of note regarding upgrading the exterior is the replacing of the windows and doors. This is necessary as the existing ones aren't serviceable.

The main interior architectural feature is the timbers in the building. It is our intention to maintain the original timbers where possible and to replace deteriorated members as required. Portions of the deteriorated second floor framing will be removed to create a mezzanine at the one end of the space. By designing the space in this fashion, the timbers are elevated from just being a structural necessity to also being an aesthetic feature. Structural upgrades will be completed as required by the engineer and the Ontario Building Code.
